Moorcroft Town Center Assessment

Creating sustainable scenarios for a community asset

Town of Moorcroft
December 2021

Prepared By:
Downtown Redevelopment
Services, LLC

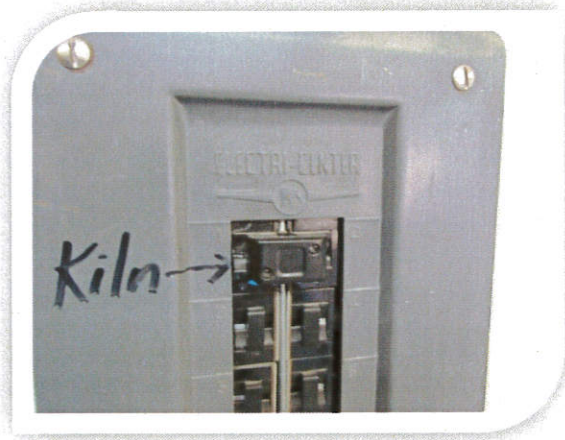
Witnessed conditions – The electrical system within the MTC building comprises various types of plans, many of which are expansions or additions to the original design. When renovations or additions have been made over the past four decades, a new panel of appropriate size, location, and construction method has been added. While modern standards consider these renovations adequate, several current electrical system problems exist. They are as follows:

- Panels are not entirely zone dedicated, as demonstrated through the significant cross over and mutual wiring
- 50% of the eight (8) panels or sub-panels observed are at capacity and have no room for further expansion
- All panels have a list of “dead” or “unused” breakers already installed
- Many boxes are not up to current manufacturer standards (meaning no longer certified by UL Laboratories or covered under manufacturers warranties) and would need to be replaced upon building rehabilitation.

While attempting to prepare a detailed analysis of the electrical system, open-ended or exposed wires, crossed wires, and improperly grounded electrical runs were notated at locations in the northern wing of the building. The building was further noticed to have cross zoning wiring to diagnose these systems further, making the tracing or zoned rehabilitation unlikely and very costly. The cross-zone wiring was verified by electrical grid tracing and yielded confusing location or layout patterns. Based on the severity of the current deficiencies, the electrical analysis is considered non-reportable without a complete electrical system analysis and tracing effort to be conducted by an electrician.

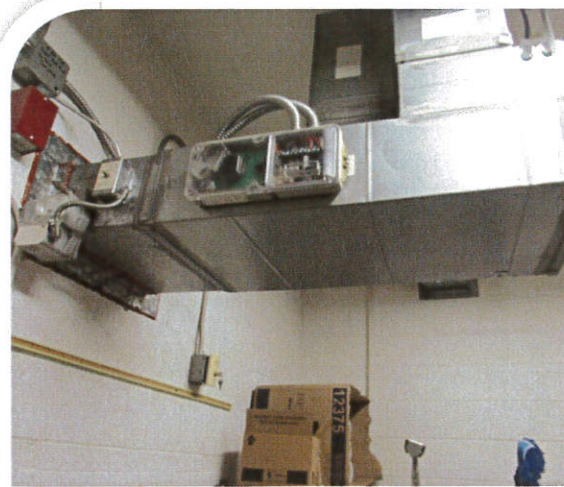
Witnessed conditions – The HVAC system for the MTC building is a coal-fired hot water boiler system, originally dating back to the 1950s. The structure runs on a singular, large-scale system located in the central courtyard of the form. Since the construction of the original design, several upgrades or alterations have been recorded, changing the furnace from coal to natural gas, then back to coal. A building permit and records search shows the last notated service as 1997, with original installation in 1956. While this system provides heating for the structure, there is no central air or cooling system currently in place for the entire network. Now, a total of four (4) rooms have mini-split cooling-only systems to supplement their cooling needs. An additional two rooms have portable air conditions (not counted as an HVAC system). These systems are located in rooms 2, 3, 37, and 39. The other system may be present but was not documented as functional. Understanding that less than 2% of the entire building has active cooling, the primary structure cooling is through fans and window movement.

- Boilers in poor to acceptable condition (visual inspection only)
- Less than 2% of rooms have cooling systems
- Long runs of more than 250 linear feet offer a drastic loss in residual heat value.

Conclusion – While centralized cooling is a desired element for eastern or Western facing habitable spaces, the currently utilized style of heating and cooling is acceptable for the current conditions of the structure, given the age of the MTC. However, as renovations are completed, it is strongly recommended that more appropriately sized heating/cooling (combined) systems are installed and normal-sized zones created. These zones should be limited to a range of 5,000 – 8,000 square feet each and have built-in redundancy options should one system go down. This effort style will ensure that the appropriate temperature and conditions are constant throughout the entire structure.

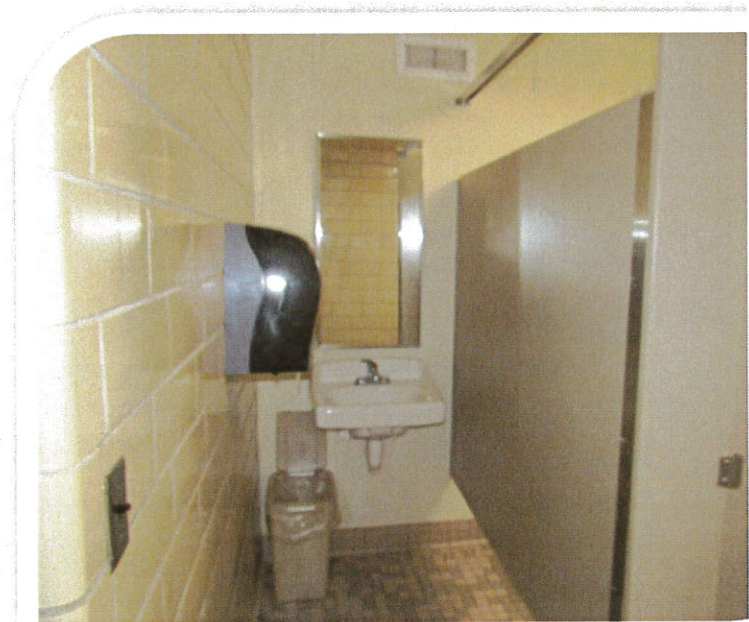
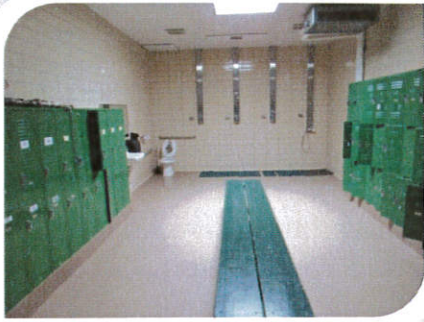
- *Restrooms* – Out of twelve restrooms, only seven are accessible. The primarily used bathrooms (room 4/5) offer partial ADA compliance with some stalls yet are limited in availability. Common reasons for lack of compliance include sink height issues, lack of turn radius inside stalls, improper door/stall partitions, etc.

- *Internal movement* – Movement within the buildings and each floor primarily meet current ADA standards. There are some areas where thresholds are higher than $\frac{1}{2}$ an inch, yet they are limited and can be altered as necessary to meet current standards.

Conclusion – To bring the entire building up to standards, many alterations or renovations would need to be made. This would include new or altered ramps, chairlift or elevator installation, Exterior or fire door replacement, creating safe refuge spaces, push bar and exit door alterations, and increased

entrances/exits to ensure appropriate ADA accessible route distances are provided. Renovations will require both superficial alterations and structural changes or upgrades to comply. As the building becomes open to the public, efforts should focus on accessible routes and accessibility in phases.

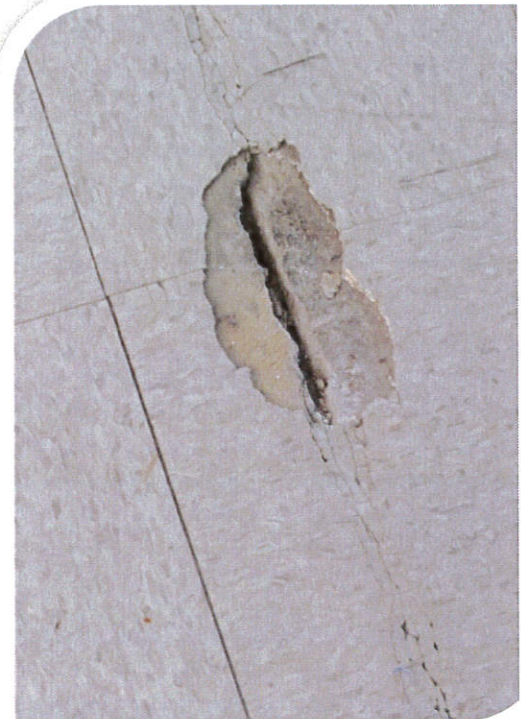
Witnessed conditions – The Moorcroft Town Center (MTC) as a building is in excellent structural condition. This is due to the mild climate and limited freeze/thaw cycle iterations, allowing the building to remain structurally competent. The building appeared to be built in four (4) different phases yet utilized a similar CMU block construction for all grades. Minor wall cracking was only noticed in the walls at one location in the Eastern hallway, and floor or ground level settling was only noted in the hallway between the cafeteria and gymnasium. The majority of the structure appears to be CMU block or structural walls with a placement style roof. All walls appear to be entire height block, fire-rated, and anchored into the concrete footers or slab. Based on the condition witnessed, it is likely that this structure would last several more generations with proper maintenance and care.

- Cracks in the Eastern hallway appear to be caused by settling just north of the window set
- Flooring cracks and damage seems to be superficial or caused by an extreme heat fluctuation
- Minor cracks (less than 1/4") were documented throughout the building
- Potential damage was notated in the weight room/stage area. Repetitious lifting and dropping weights appear to weaken the joists that hold the floor in this room up. Damage to the basement stucco.

Conclusion – The building is in remarkable structural condition. Many rooms will require structural wall removal or alteration if smaller or larger rooms are needed as part of the rehabilitation process. While the building is structurally competent, modern upgrades would be tough to complete with the utilized or period-specific construction methods.

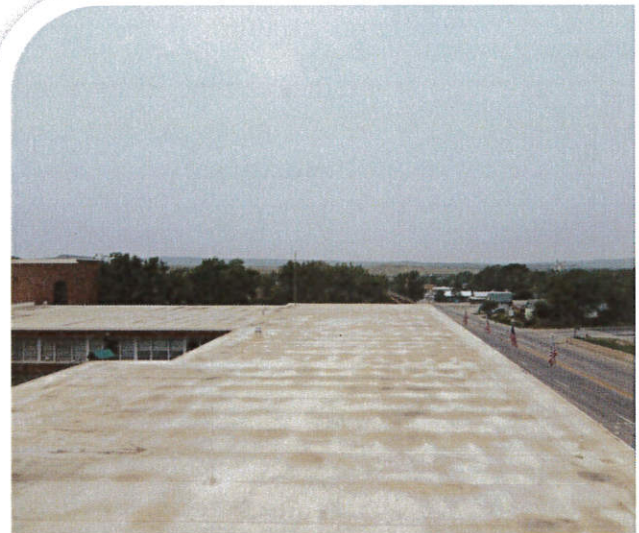
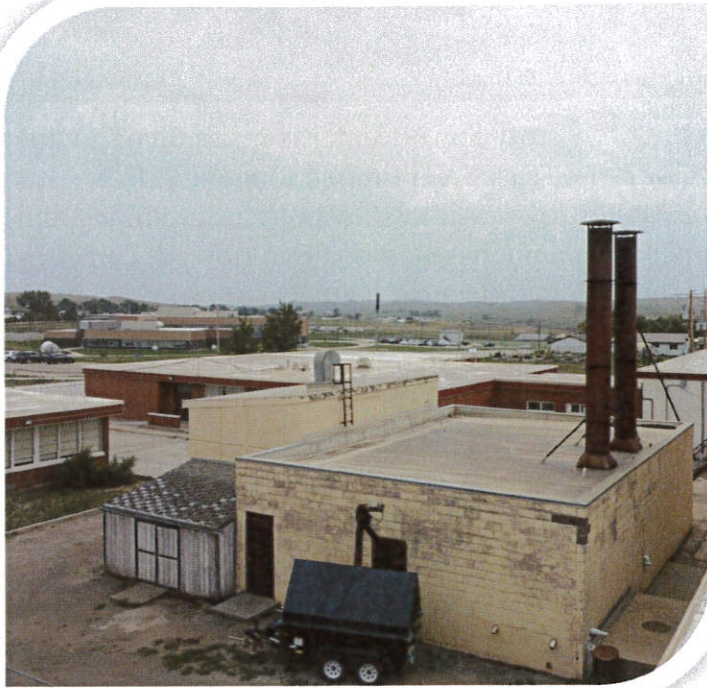
Witnessed conditions – The building envelope for Moorcroft Town Center is acceptable to fair condition, showing age and shapes suitable for the construction method and year of construction for the structure. While the building has been constructed in several additions over seven decades, the style of exterior building materials has remained consistent throughout. The brick exterior materials are in reasonable condition with minor wear and tear, yet could use sealant or attention over the next five (5) years. The aluminum single pane windows are primarily operational, yet are not heat/cooling efficient, averaging a temperature difference of -5.9 degrees when conditions are cooler outside and +11.1 degrees when conditions are warmer outside. This thermal drop illustrates a difference of up to 17 degrees in the afternoon with direct sunlight. The condition of the windows is in poor to fair condition, demonstrating surface oxidation and cracked or easily removable window caulking/chinking. There are no gutters around the structure's perimeter or internally within the roofing materials. However, sections of the roof have internal roof drains, yet the roof appears not to be appropriately sloped to drain water towards the drainage points. The roof is a membrane roof with considerable leaks and damage. The leaking condition of the ceiling has further caused damage to the interior of the structure in numerous classrooms. Some of this water damage is historic (dating back up to ten years), while others are recent enough still to have wet flooring materials in August during our inspection. Exterior doors are in acceptable condition, many of which include safety glass.

Overall the structure of the buildings is in acceptable condition except for the roofing surface, which is in poor condition. The roofing will require a complete replacement and repairs for all affected systems located under the membrane roofing, such as:

- Joists and hangers
- Sheathing or metal decking
- Electrical or wood damage
- Mold and mildew abatement

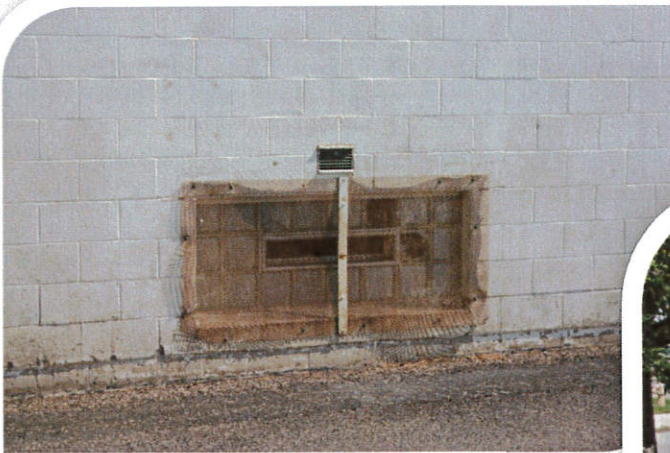
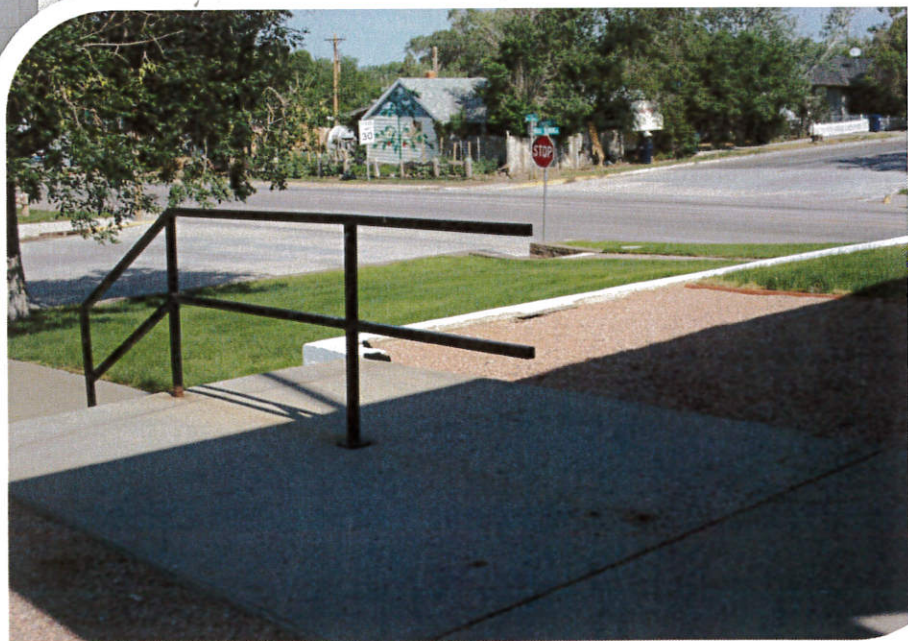
- Average of seven (7) windows per room
- Average heat gain at windows of 11.1 degrees
- Average heat loss at windows of -5.9 degrees
- The usable life of fewer than five years for most windows
- 90% of windows are more than 30 years old – as dated by manufacturer style and construction.
- Exterior doors are showing wear but still have considerable usable life left
- Roof surfaces are failing in numerous locations
- Exterior fire escape from the teen room (second floor) should be removed as it is no longer structurally competent.

Conclusion – The exterior of the building is in acceptable condition except for the membrane roof. The body of the building has a considerable usable life yet could benefit from regular maintenance, including upgrading the windows and doors to more thermal barrier varieties.

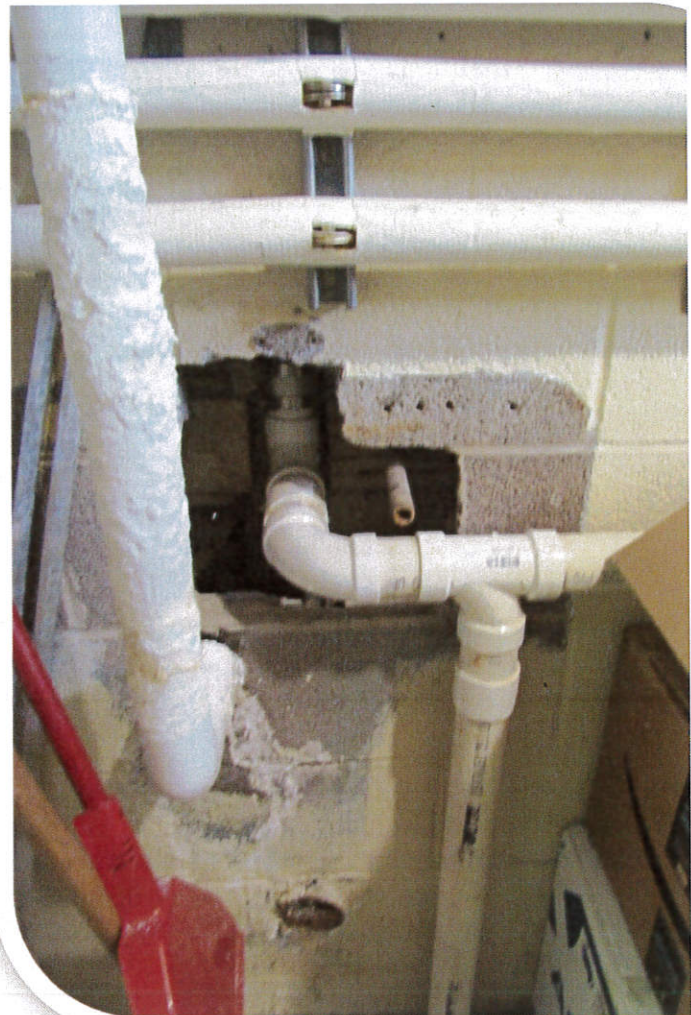
Witnessed conditions – The MEP system in the Moorcroft Town Center is made up of a variety of materials and sizes, creating a system of unknown diseases and limited longevity. In a building that is more than 50 years old, it is not abnormal to witness a variety of plumbing and mechanical systems. All plumbing fixtures and basins demonstrated positive flow, documenting limited to no obstructions in the evacuation system. Water disbursement also appeared to work as designed, yet several water supply pipes are below standard sizes or are attached/integrated into non-standard locations. All fittings and fixtures appeared to be in fair to good condition yet demonstrated an average amount of wear for their age. While the plumbing system is still functional, there are a few concerns or unusual items, specifically:

- ½" and other smaller sized water supply lines to restroom sinks
- PVC and cast iron pipes utilized in the same drain line run, piecing together a system instead of proper replacement
- Limited amounts of exhaust vents or stacks in restrooms
- Little to no vent fans or air circulation methods in restrooms
- Chrome clad pipes that are oxidizing in many in-room drinking fountain waste lines
- Smaller than 2" drain pipes in the older section of the building
- Linking sink/faucet/fixtures in several classrooms equipped with the service

Hot-water heaters were not evaluated as part of this review, yet hot water at each available tap was verified for applicability. However, it should be noted that the quality of water and documented calcium buildup on piping in and around water heaters demonstrated a need to be replaced in the next 3-5 years. This is not abnormal as most water heaters do not average a life span of 7-10 years, assuming appropriate maintenance is undertaken.

Conclusion – The plumbing system within the building is in operable condition yet will require considerable renovation or consolidation to make the system efficient and reliable. The system has a 10+ year usable life if it is adequately maintained. Renovation work will likely require considerable structural changes or upgrades to accommodate newer standards. Phased or scheduled upgrades would make the renovation work attainable.
